“The bolt pays dearly for its coat – like a fox to its fur”

Division of Responsibility

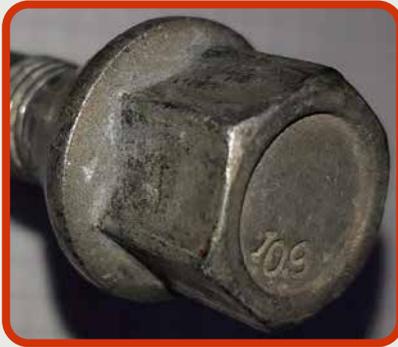
▼ Fig. 5. Plagiarism

It is more difficult to determine the guilt in the case of unknowingly applying plagiarism. *Fig. 5* shows a bolt that has come loose from the wheel of a truck while driving. At first glance, it is clear that this is plagiarism. According to ISO 898-1, each structural bolt must be provided with information about the strength class and the manufacturer's mark. In this case, the declared strength of 10.9 was not confirmed and the manufacturer's mark was missing. In most cases, the suppliers of plagiarism are anonymous. So who is responsible in such a case? The decision is up to the arbitrator.

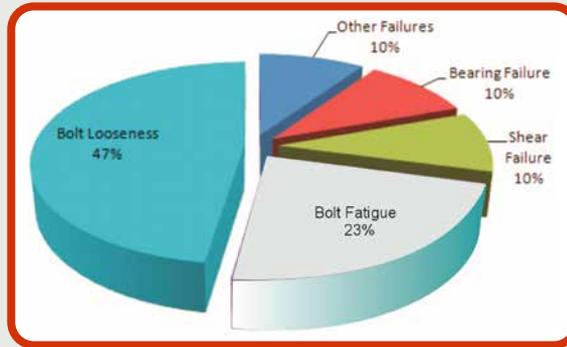
▼ Fig. 6. Failure frequency

There are many cases of collapse of entire structural units due to failure of bolted joints. The reasons are various. As SKF's experience shows, the most common are bolt or nut loosening and material fatigue (*Fig. 6*). In such complex cases, the arbitrator has expert opinions prepared by several independent expert institutions. Unfortunately, these expert opinions often differ from each other or do not contain clear-cut opinions, because usually none of the academics has mastered the theory of the behavior of bolted joints during assembly and operation. They will examine material changes with the help of REM microscope in vain if no one notices that in a given case the contact surfaces were not parallel (*Fig. 11*).

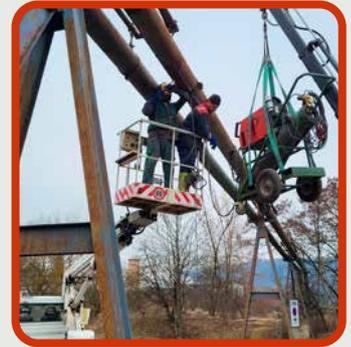
▼ Fig. 7. Pipeline at height

Cases of loss of tightness of flange joints in hard-to-reach places (*Fig. 7*) are also complicated. A leak in a flange connection can have fatal consequences. An explosion of the leaking gas demolished the surrounding residential buildings (*Fig. 8*). Corrosion is also dangerous, especially for pipes. There are several types, which are regulated by the ISO 8044 standard - Corrosion of metals and alloys. For the purposes of this publication, a specific breakdown of corrosion types is shown in *Fig. 9*. The least dangerous is surface corrosion visible to the naked eyes. The most dangerous type is what can be called insidious because it cannot be identified. The best known are hydrogen embrittlement (*Fig. 10*) and stress corrosion (*Fig. 11*). This image shows that the cause of the crack under the screw head was the non-parallel contact surfaces.
